# Pretty Lake Post-Construction Monitoring Report

July 6, 2018

Project No. J16X402500

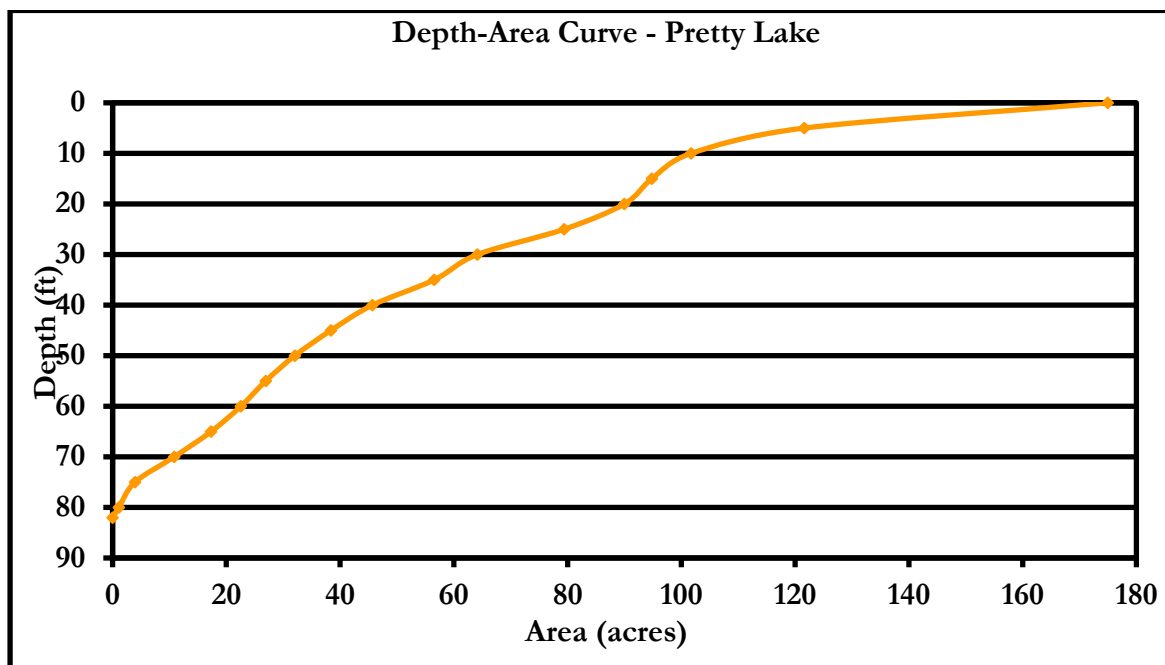
Figure 10. Depth-area curve for Pretty Lake.

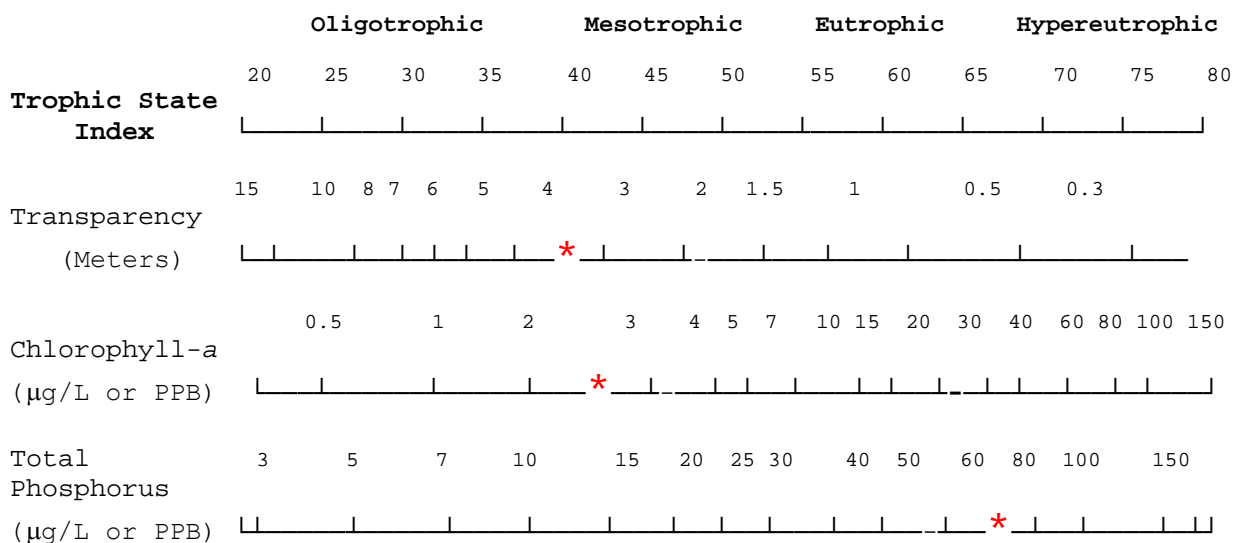
**Figure 11. Carlson's Trophic State Index with Pretty Lake results indicated by red asterisks.**

Developed by Bob Carlson (1977), the Carlson TSI is the most widely used and accepted TSI. Carlson analyzed summertime total phosphorus, chlorophyll *a*, and Secchi disk transparency data for numerous lakes and found statistically significant relationships among the three parameters. He developed mathematical equations for these relationships, and these relationships form the basis for the Carlson TSI. Using this index, a TSI value can be generated by one of three measurements: Secchi disk transparency, chlorophyll *a*, or total phosphorus. Data for one parameter can also be used to predict a value for another. The TSI values range from 0 to 100. Each major TSI division (10, 20, 30, etc.) represents a doubling in algal biomass (Figure 11).

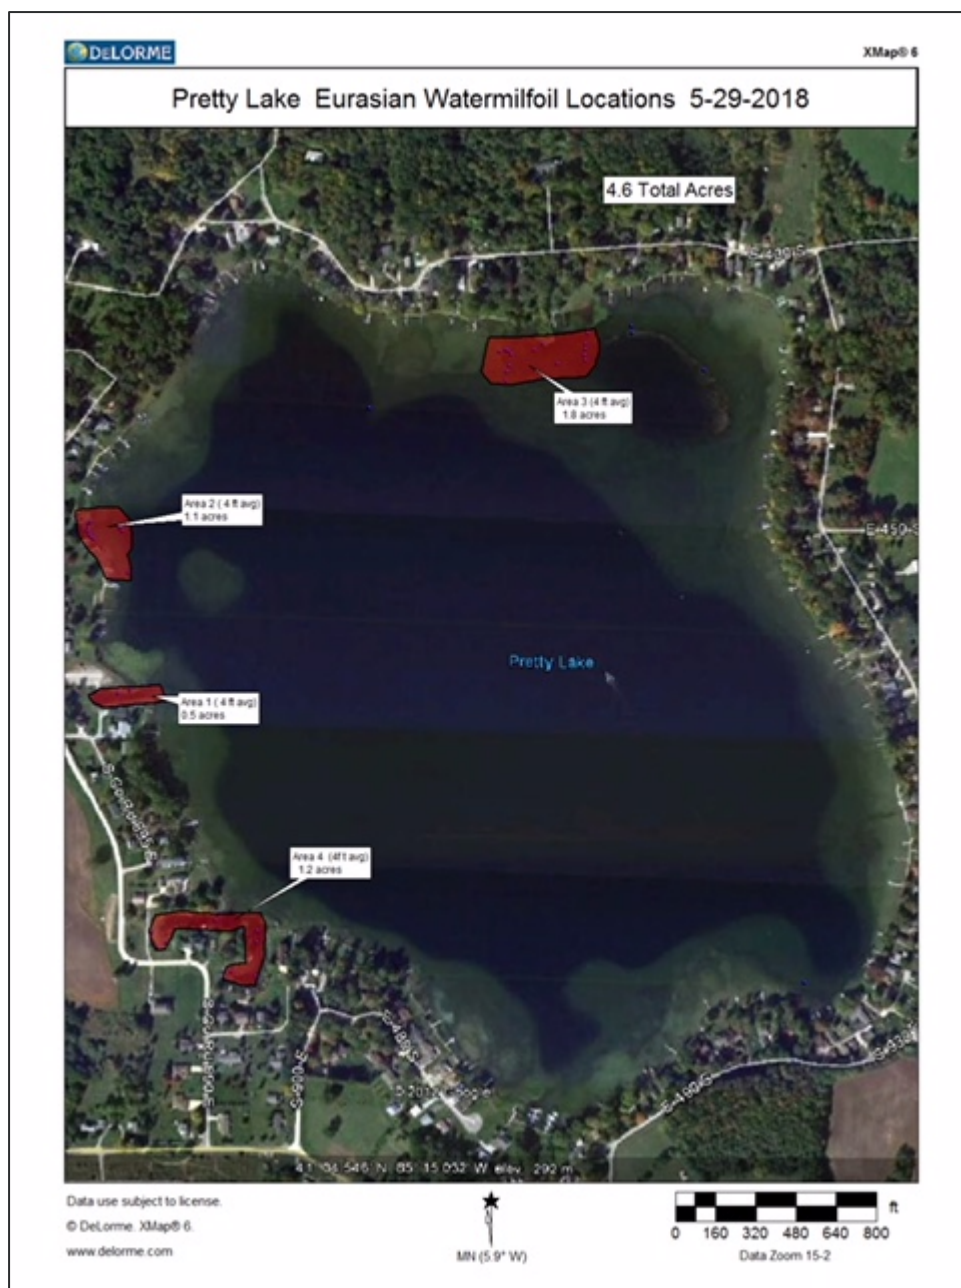
**Figure 17. 2018 Eurasian watermilfoil treatment areas within Pretty Lake. Source Aquatic Weed Control.**

invasive plant abundance after 3 years of aggressive early season treatments. Figure 16 below was provided Aquatic Weed Control and shows the areas of Pretty Lake with historical Eurasian watermilfoil presence and areas treated since 2013. Figure 17 outlines the 4.6 acres to be treated in 2018. A comparison of Figures 26 and 27 and review of historical treatment acres in Table 36, indicates efforts to control Eurasian watermilfoil is working and appears the species is at a manageable level.

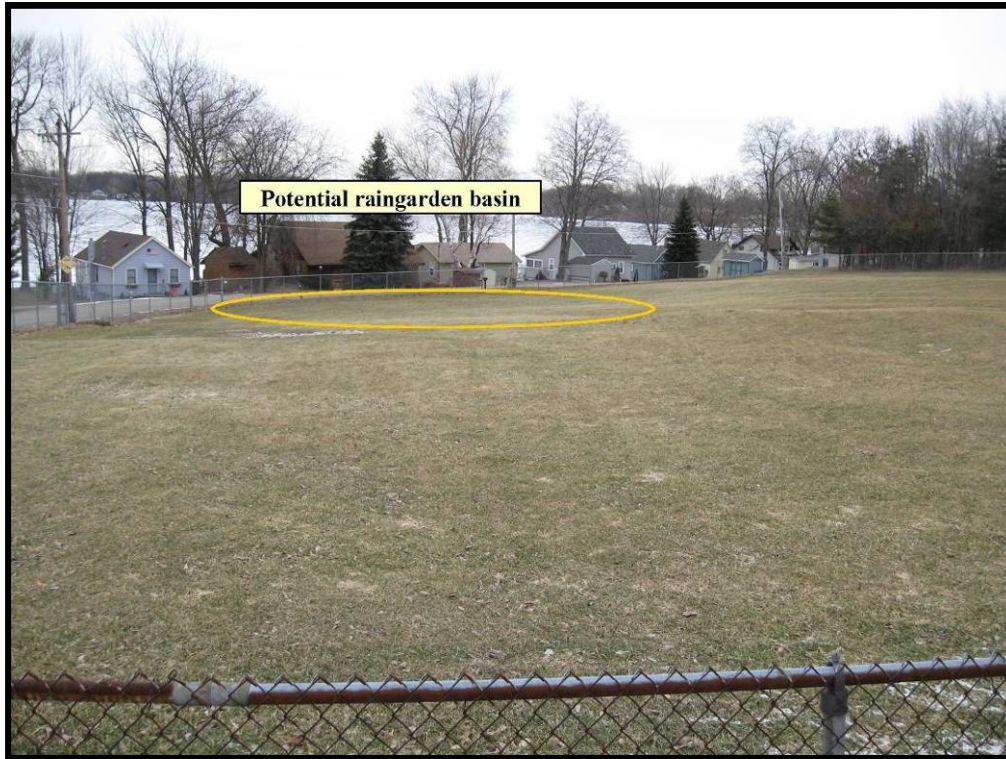
**Figure 20. Potential raingarden basin site at the Milford Elementary School (Site 2). Photo taken from 2009 Feasibility Study report.**

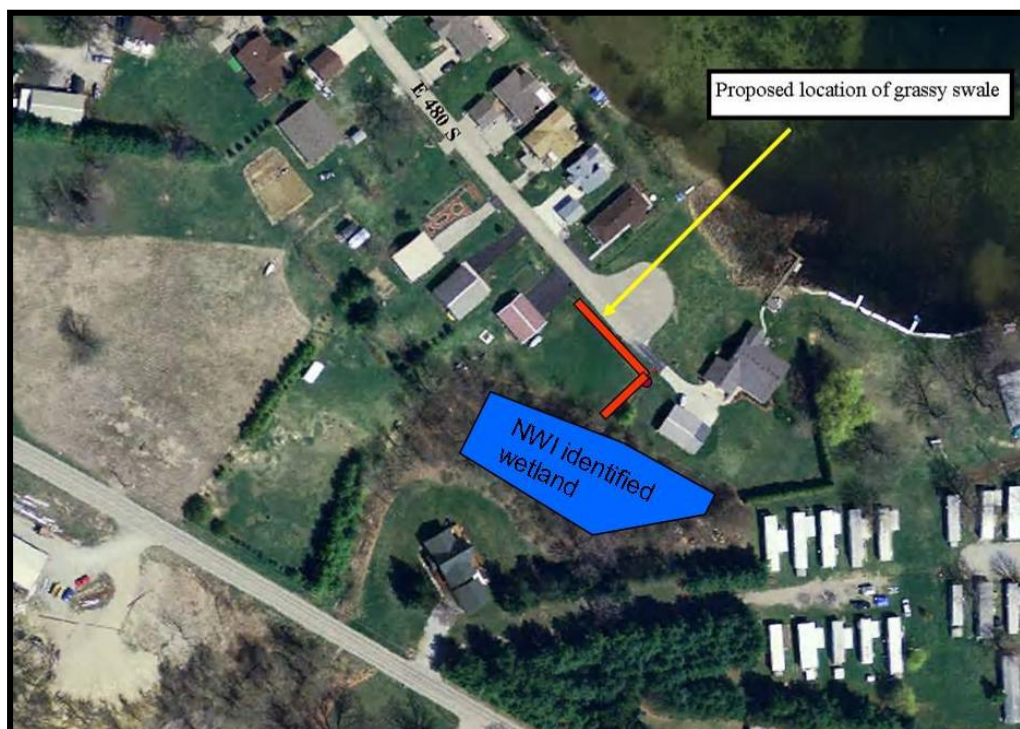
**Figure 21. Location of Site 4 and areas recommended for the construction of a grassy swale, Note the NWI wetland to the south of the designated project area. Figure taken from the 2009 Feasibility Study report.**

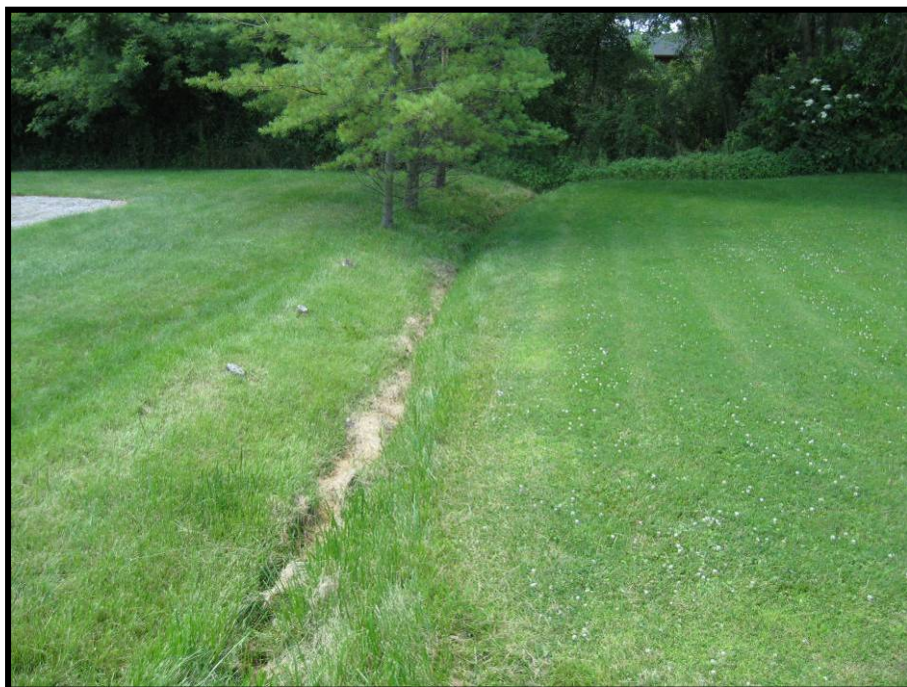
**Figure 22. Example at Site 4 of the narrow channel dominated by turf grass. Photo taken from the 2009 Feasibility Study report.**

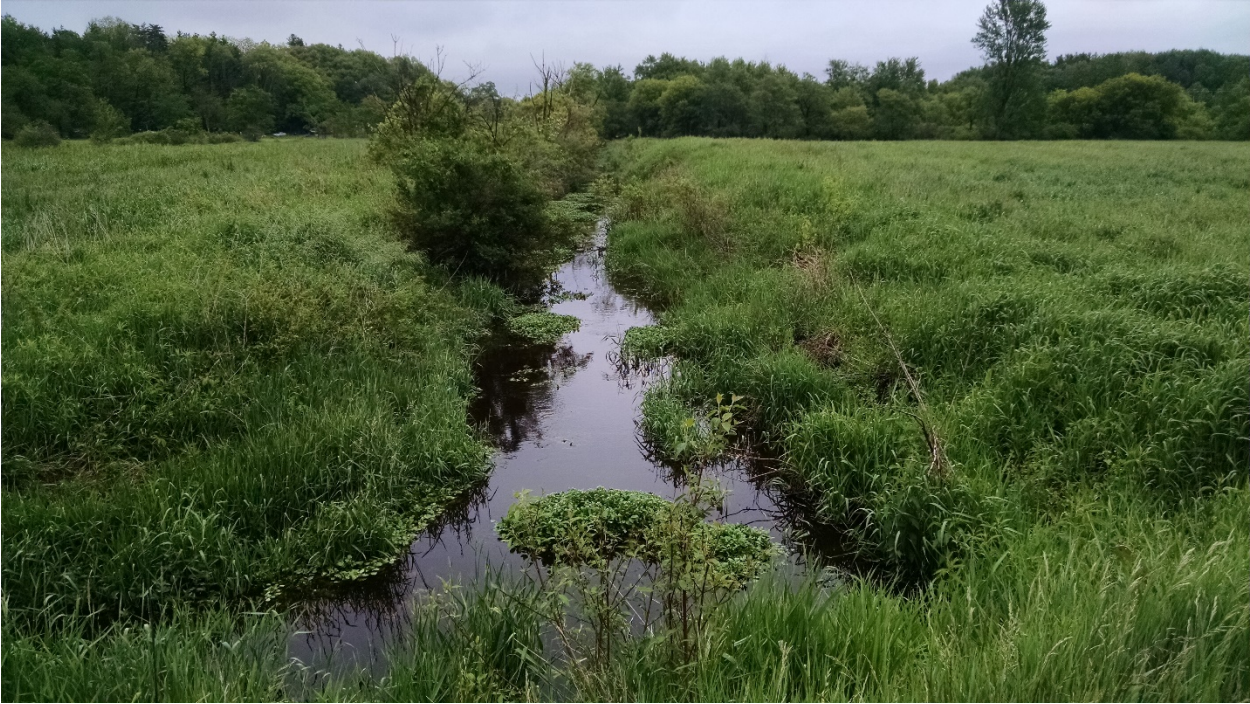
**Figure 23. View facing east (downstream) from CR 875 E of Deal Ditch at Site 7 taken during the May 2017 tributary sampling event.**

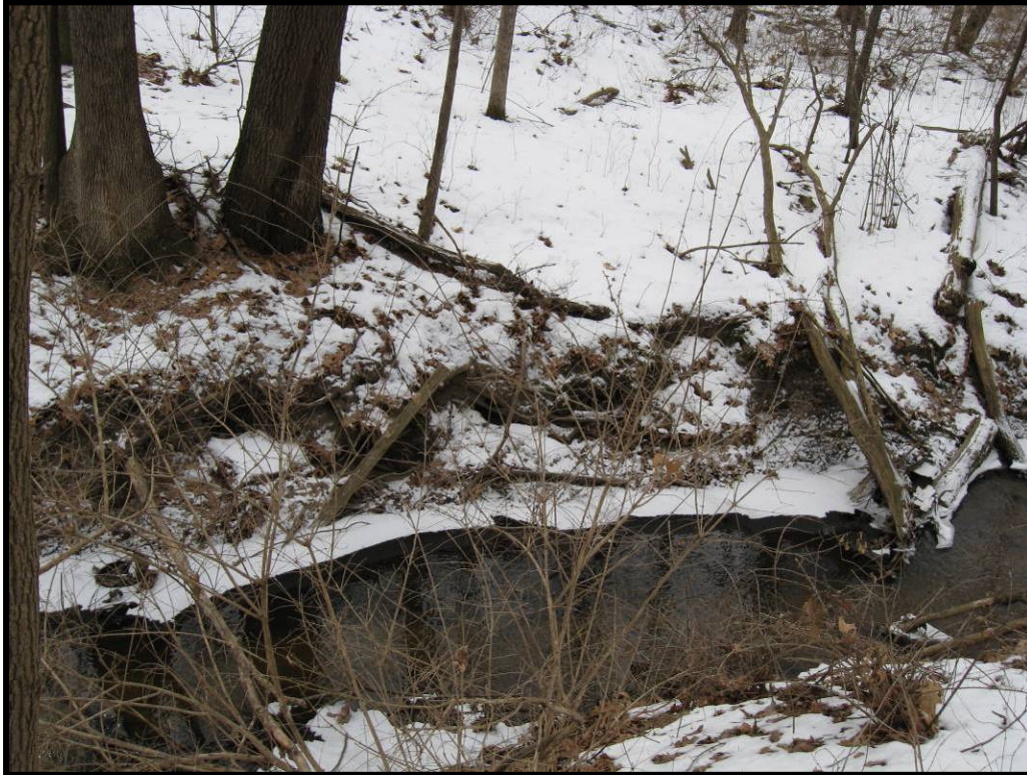
**Figure 24. Example of erosion occurring on streambank at Site 8. Photo taken from the 2009 Feasibility Study report.**

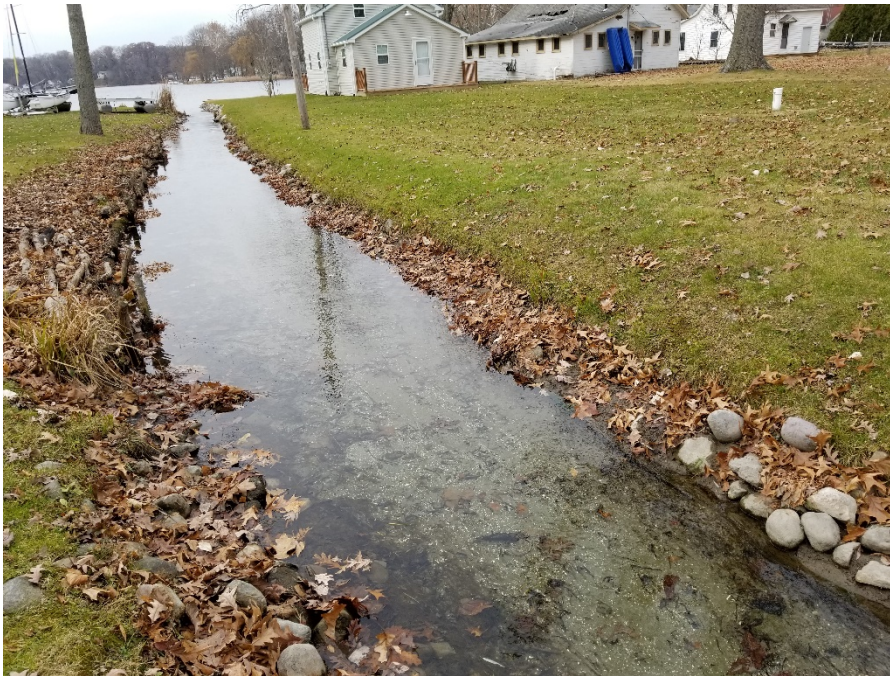
**Figure 25. View facing upstream of streambank erosion on outlet stream. Photo taken during December 2017 watershed tour.**

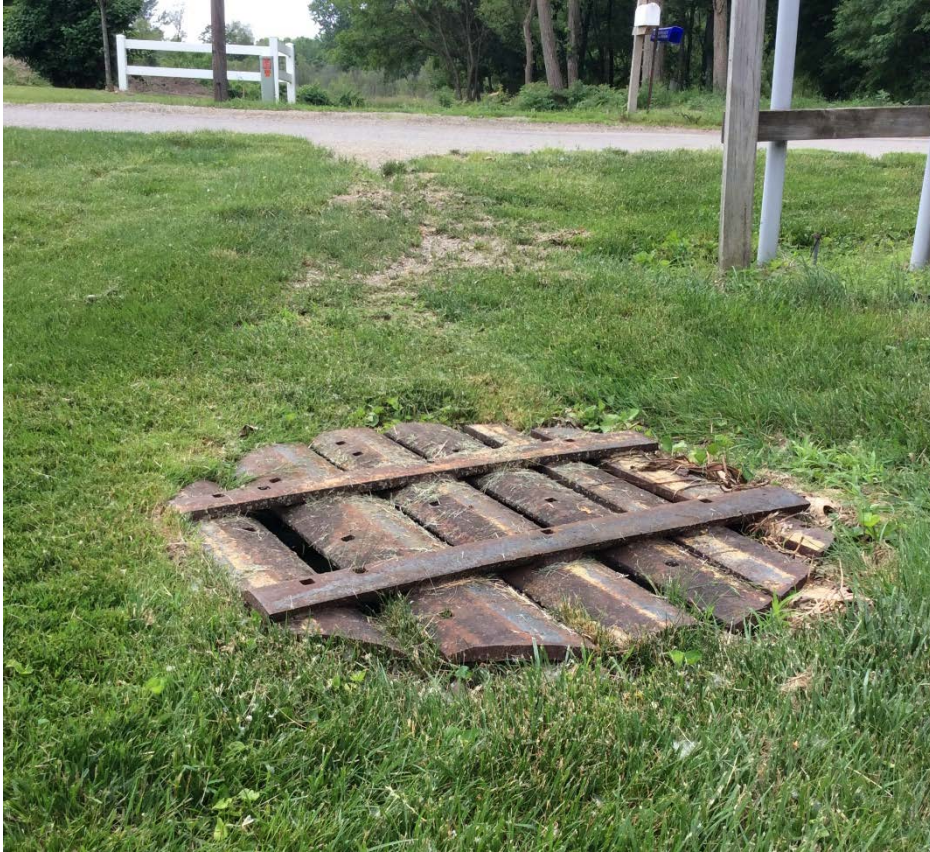
**Figure 26. Photo of existing catch basin grate located on east-side of CR 890 E, approximately 600 ft. north of the Public Access.**

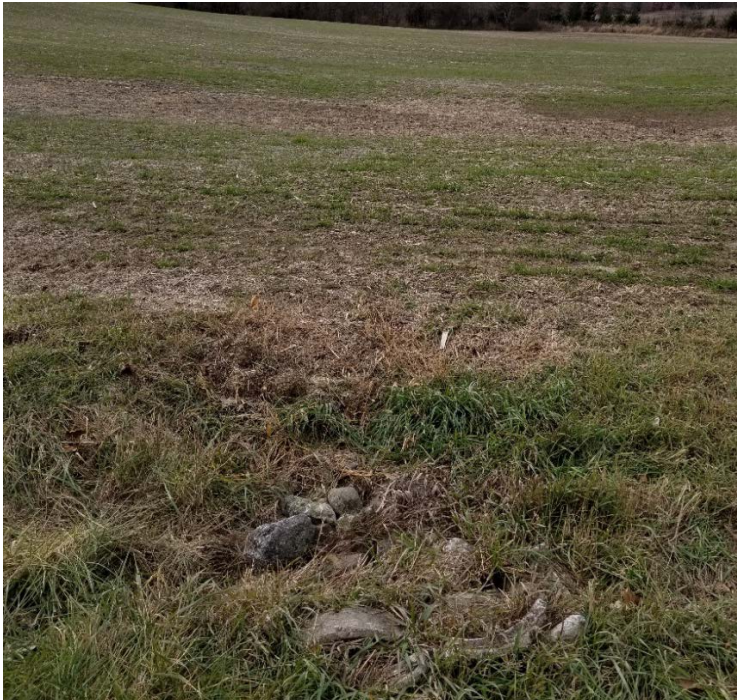
**Figure 28. Photo of catch basin located on west-side of CR 890 E, near the public access. Catch basin opening is located within the rocks visible at the bottom margin.**

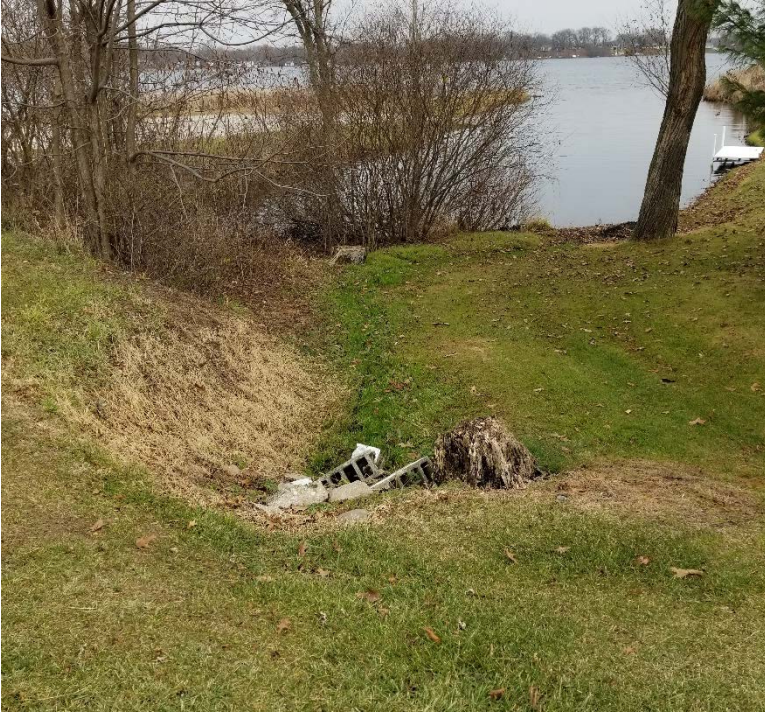
**Figure 29. Photo of eroding catch basin spillway on east-side of CR 890 E, near the public access.**

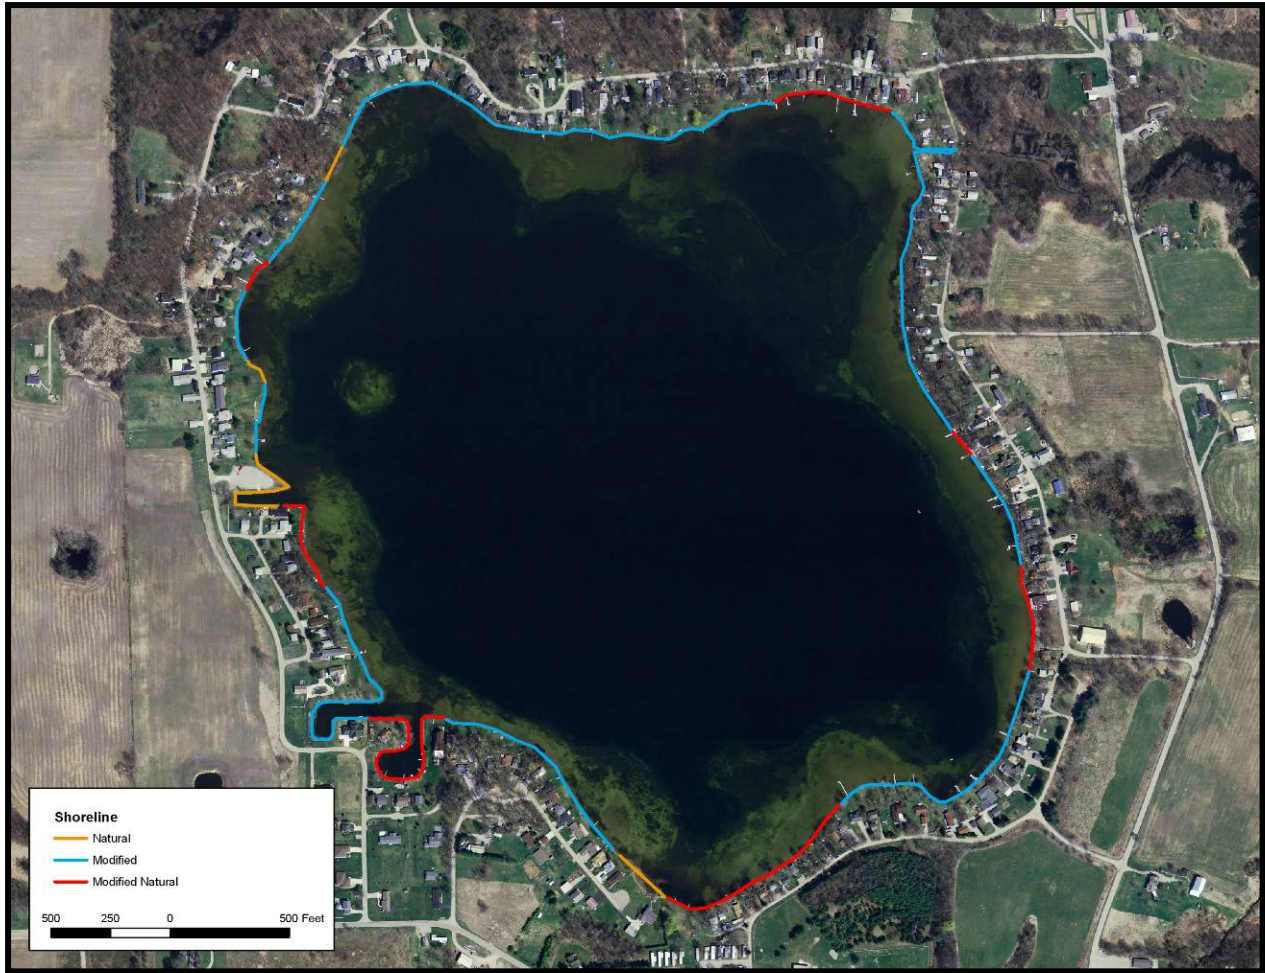
**Figure 30. Shoreline surface type observed at Pretty Lake, August 2, 2006.**

One management measure or initiative that could be a focus of the PLCC around the lake would be the development of a program aimed at increasing the number of natural shorelines, modified natural shorelines and/or shoreline native plant buffer zones around the Pretty Lake. Restoring Pretty Lake's shoreline by planting the area with native vegetation will return the functions the shoreline once provided the lake. In addition to filtering runoff, well-vegetated shorelines are less likely to erode, reducing sediment loading to the lake. A program such as this would seek to convert existing hard armoring shoreline such as seawalls, into more natural materials, modify seawalls by adding a glacial stone toe to the front of seawalls and/or adding native plant buffers at the shoreline. As outlined in the 2007 Diagnostic Study, development around the lake is extensive and 92% of the shoreline had been altered in some form (Figure 30).

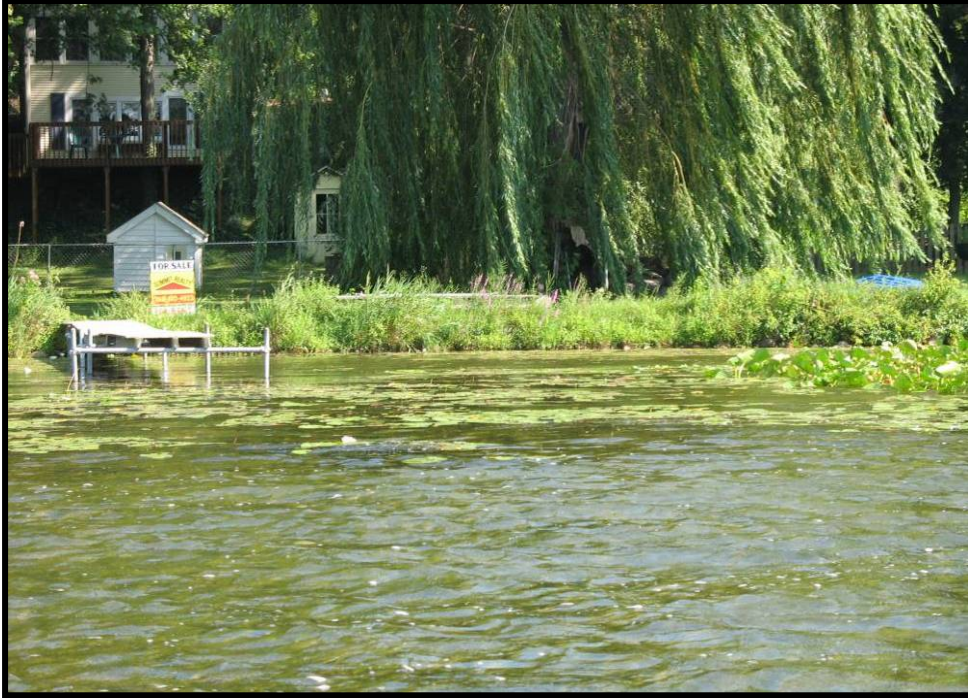
**Figure 31. Modified natural shoreline present within Pretty Lake taken during 2007 Diagnostic Study. Note that vegetation was removed in areas required to place the dock for access to the lake. The remaining vegetation along the shoreline acts as a natural buffer.**

Along much of Pretty Lake's shoreline (64%; 8,735 feet or 2,662 m), trees and emergent vegetation have been thinned; however, these areas possess at least a narrow band of emergent plants. These areas are mapped as modified natural shoreline because they still possess at least a small portion of all these strata (submerged, emergent, and floating). Other portions of the shoreline that are also mapped as modified natural include those areas where individuals removed only the portion of the shoreline vegetation required to view or access the lake. Figure 31 displays the portion of shoreline possessing modified natural characteristics.
